Inspection system for the conservation of flexible pavements through the Cascade Trainer algorithm and the use of the DJI Mini 4 Pro drone

(Sistema de inspección para la conservación de pavimentos flexibles mediante el algoritmo Cascade Trainer y el uso del dron DJI Mini 4 Pro)

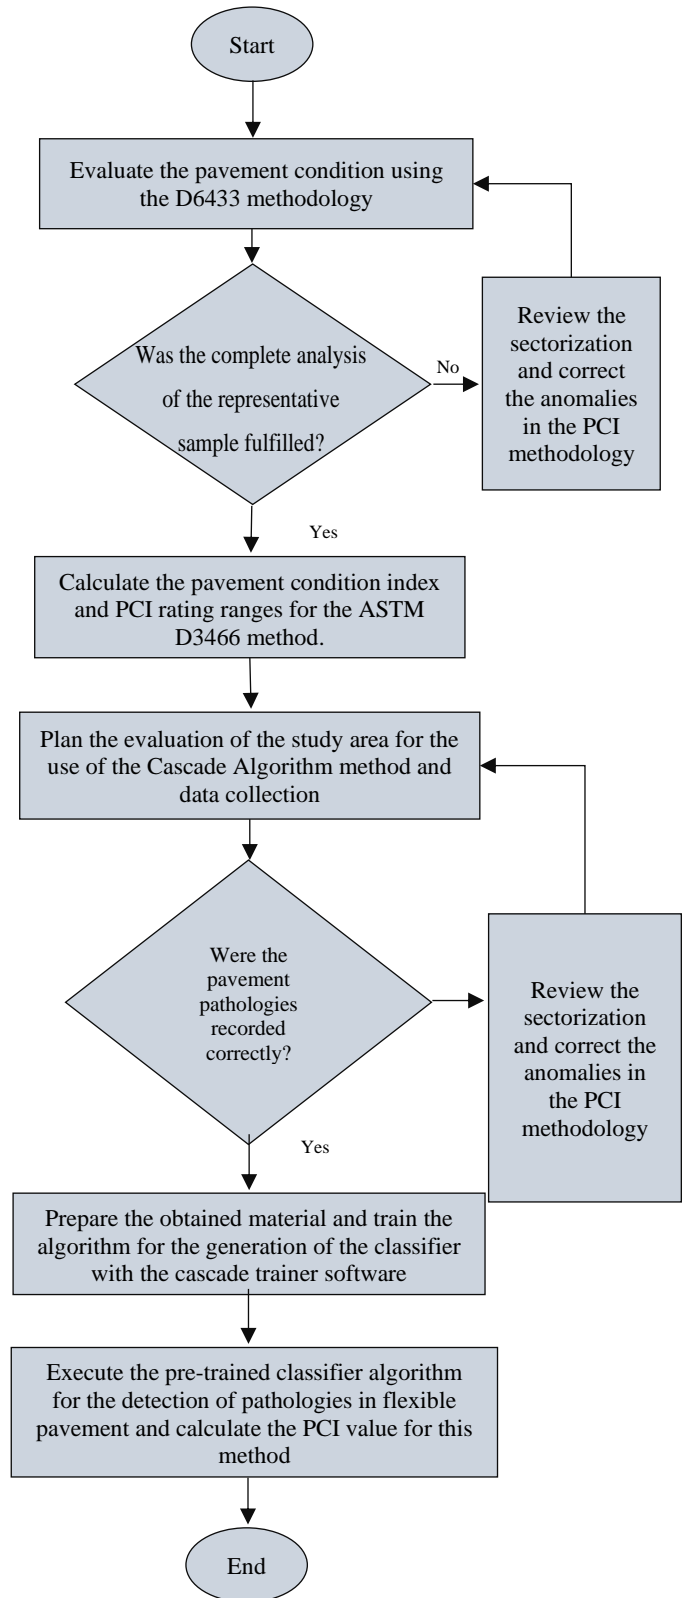
Fig. 1. Flowchart of the procedure

B. Procedure

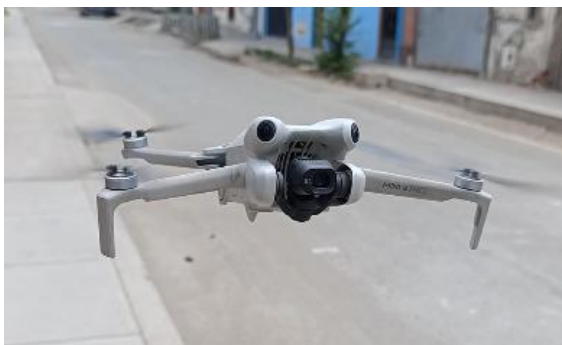
Fig. 2. Drone DJI Mini 4 Pro

Note: The drone records in high resolution (4K), has a range of 18 kilometers and 39 minutes of flight time. However, the route we evaluated took us approximately 10 minutes. Later, high-quality images were collected, as we can see in Figure 3.

To evaluate the avenue using the drone (DJI Mini 4 Pro), the work team planned the aerial route considering the various restrictions that could arise during the flight. For example, the flight zone, flight altitude, schedule, and video image quality were taken into account. Finally, the study area was filmed with the drone, considering the expected image quality.

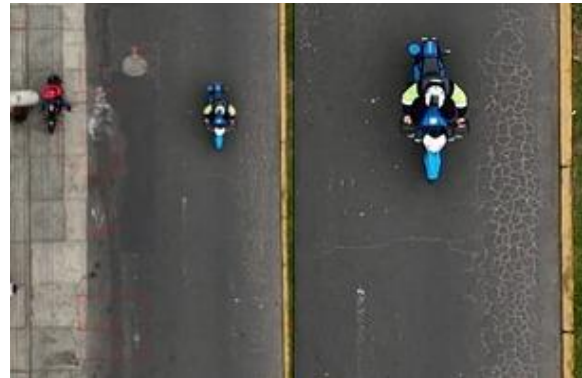
Fig. 3. Frames of the DJI Mini 4 Pro drone

Note: Frame extracted from the video taken with the DJI Mini 4 Pro drone, which serves to exemplify the image quality and the visibility of the defects in the photos.

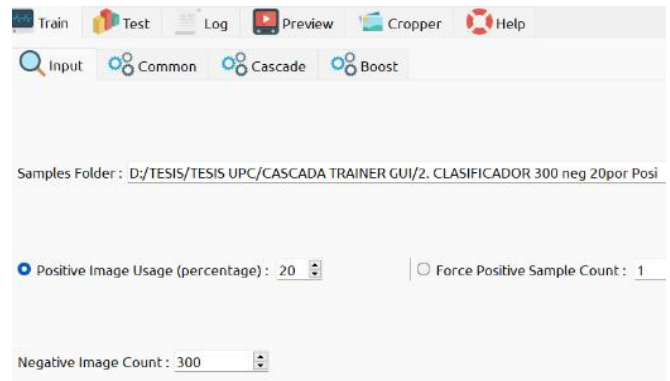
On the other hand, in the negative images, we will place all those that we want to avoid, such as cars, people, trees, etc. Once this is done, we start the training in Cascade Trainer using a configuration of: 300 negative images and 20% positive images (70 samples). This is shown below in Figure 5:

Fig. 5. Interface in the 'Train' section of Cascade Trainer GUI.

After completing this process and starting the training, a folder named 'classifier' will be generated. Inside it, we will find a file in '.xmlfile' format named 'cascade', which will be our classifier algorithm.
